# Cox Ditch and Otter Creek Macroinvertebrate Biomonitoring Results (1991-94)

Indiana Department of Natural Resources  
Division of Soil Conservation  
Lake and River Enhancement Program

Vigo County Soil and Water Conservation  
District

June 1995

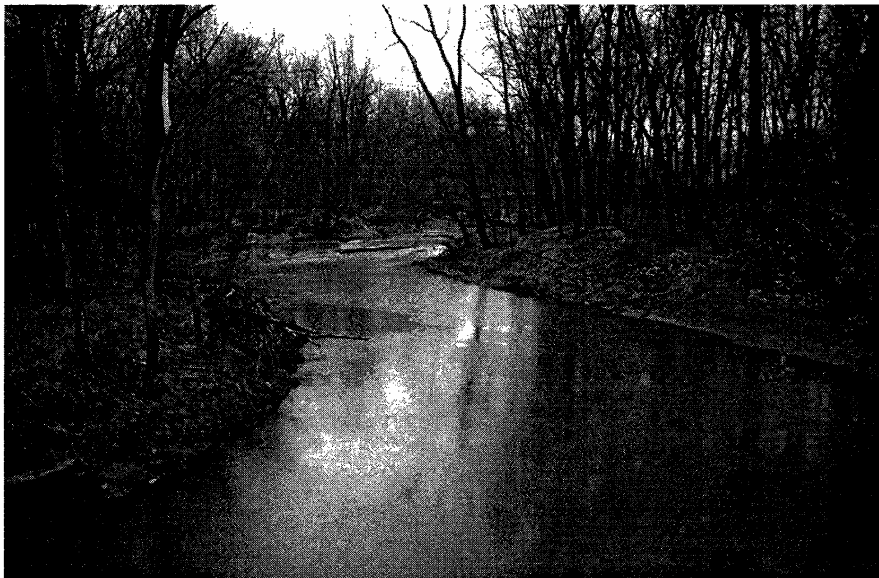
Many habitat characteristics at site M1 did not appear to have changed appreciably from 1991. As stated previously, the author was a member of the sampling team that sampled Otter Creek in 1991. Wide riparian zones of well-established woody vegetation were still present on both sides (figure 4.3.1-1). Instream habitat was provided by large woody debris. (Large woody debris alters the hydraulics of the stream creating small pools and riffles, alters substrate composition by scouring out sand and leaving gravel, and traps and concentrates organic materials in the eddies it creates.) Aside from riffle areas though, the majority of the stream substrate was composed of shifting sand which provides little habitat for macroinvertebrates. A gravel substrate was present in riffle areas, but in limited quantities only. The specific riffle sampled in 1991, although present, appeared to be somewhat degraded. As mentioned previously, a different riffle approximately 100 m upstream was judged to have superior substrate characteristics and was sampled instead.

**Figure 4.3.1-1. Otter Creek at CR 24 West (view looking upstream, 4/3/95).**

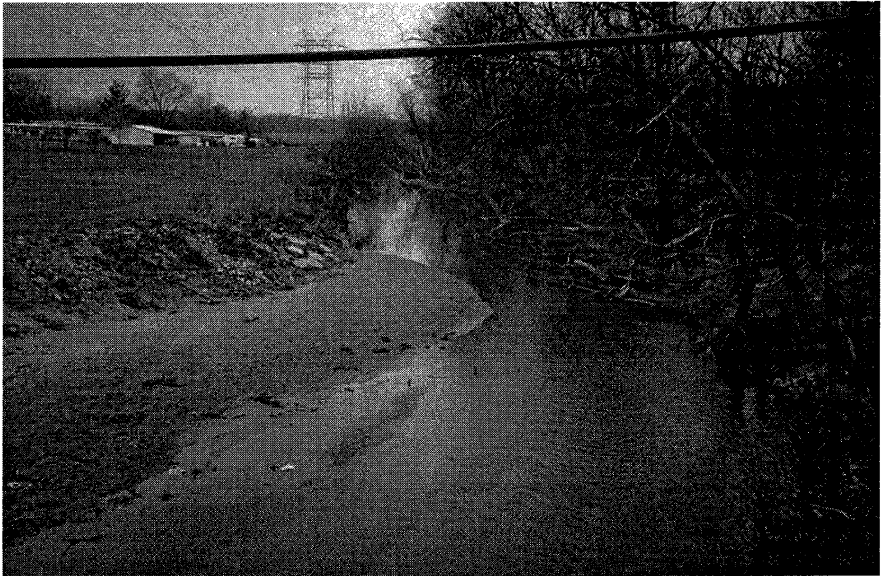
The habitat characteristics at site M2 appeared to have been radically altered. In 1991, the south bank had a dense stand of young (diameter less than three inches) trees. This is verified by the 1991 habitat assessment forms that indicates a thin 5-10 m riparian zone of woody vegetation. Additionally, the drawing of the stream channel on the same form indicates a much more complex instream channel morphology. However in 1994, the woody vegetation on the south bank had been removed (figures 4.3.1-2 and 4.3.1-3) and the instream channel morphology had been greatly simplified.

**Figure 4.3.1-2. Otter Creek at Business 41 (downstream, 4/3/95).**

The drastic changes in macroinvertebrate community structure may be related to powerline right-of-way maintenance. High-tension powerlines (background in figure 4.3.1-2 and extreme left of figure 4.3.1-4) cross Otter Creek in the vicinity of the biomonitoring sites. In fact, one powerline crosses Otter Creek nine times. The first crossing occurs approximately one mile upstream of site M1. The second crossing occurs at site M2. The same line crosses four more times between sites M2 and M3 and three more times upstream of site M3. It then crosses Sulfur Creek and several tributaries to Sulfur Creek. A second powerline crosses once on both Otter (upstream of site M3) and Sulfur Creeks. A third power line crosses Otter Creek near its mouth (downstream of site M1). Additionally, the second and third power lines make multiple crossings on Gundy and Cox Ditches (USGS 1962, USGS 1963). However, since little woody riparian vegetation exists along Gundy and Cox Ditches, it is likely little maintenance is performed here and impacts to water quality in this area due to power line maintenance should be minimal.

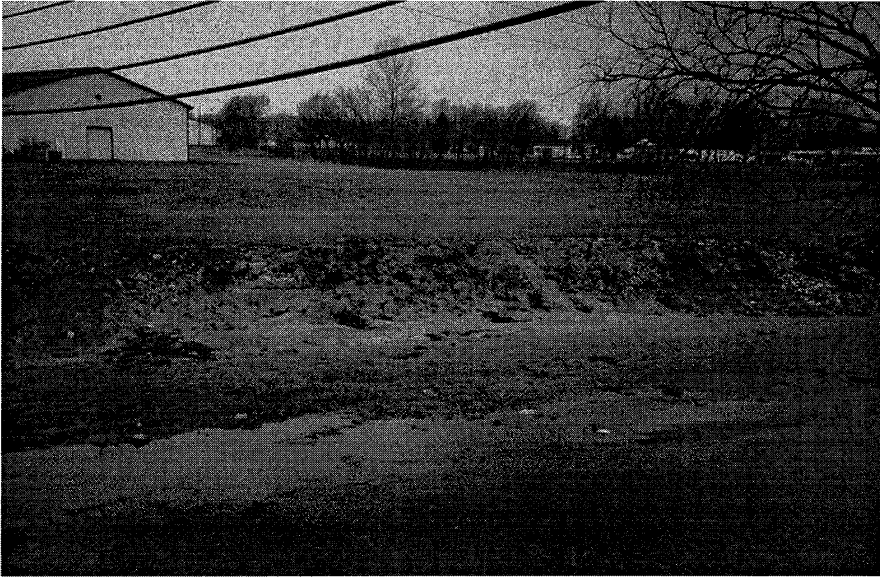
**Figure 4.3.1-3. Otter Creek at Business 41 (downstream, 4/3/95) showing area of vegetation removal on south bank.**

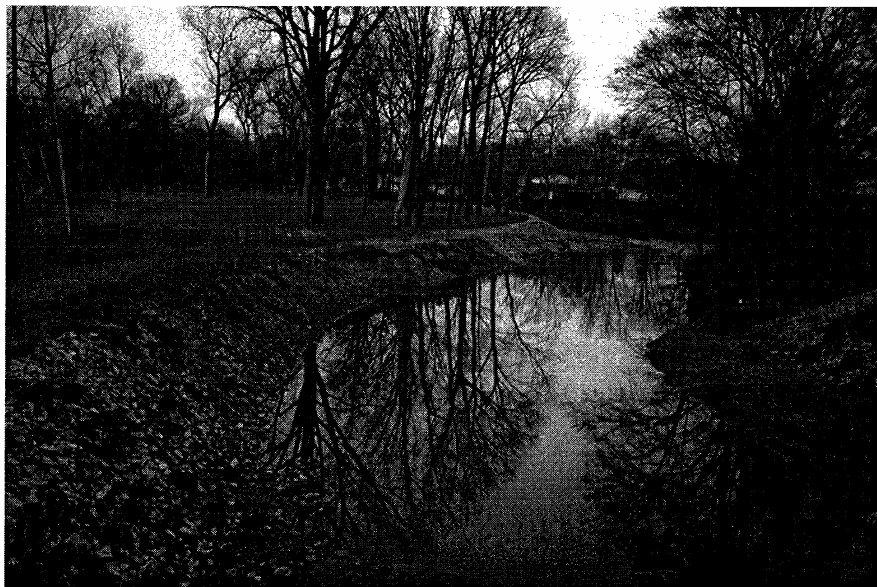
Additionally, the north bank upstream of the business 41 bridge was denuded of vegetation and partially covered with rip-rap. Rip-rap is the term for the white stones covering the upstream banks in figure 4.3.1-5. The stones are typically composed of limestone and are used to prevent streambanks from eroding away after vegetation removal. Rip-rap is typically thought to be innocuous and in some cases can provide habitat for certain sunfishes -- green sunfish, longear sunfish, and rockbass -- and macroinvertebrates (author's personal observation). However, there are several potential problems with rip-rap.

**Figure 4.3.1-5. Otter Creek at Business 41 (upstream, 4/3/95) showing rip-rap and lack of woody vegetation.**

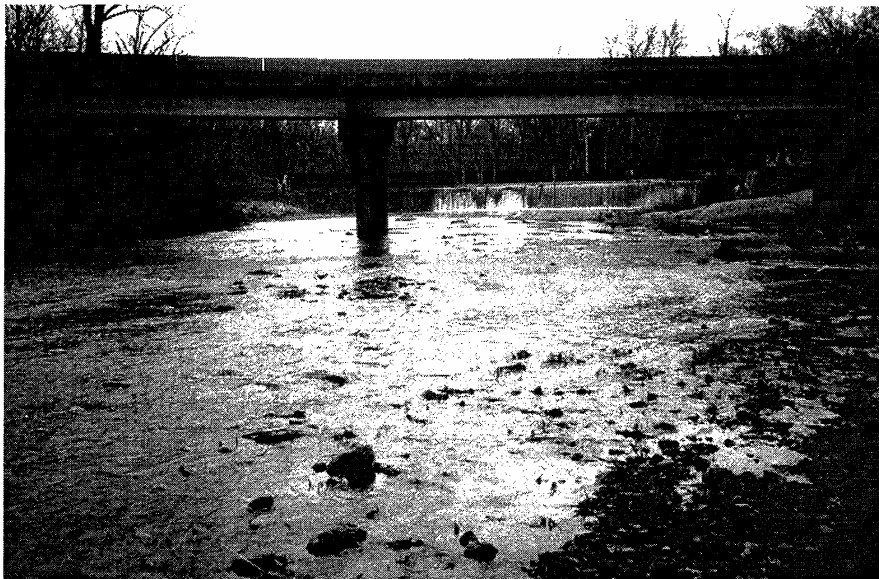
Further upstream is site M3. It is located just downstream from the Old Mill Dam (figure 4.3.1-6). The mill dam is the centerpiece of a small park. Trees line the north bank. The south bank is mostly mowed grass. The instream habitat at this site is radically different from that at sites M1 and M2. The substrate is a bedrock outcrop.

**Figure 4.3.1-6. Otter Creek at Old Mill Dam (upstream, 4/3/95).**

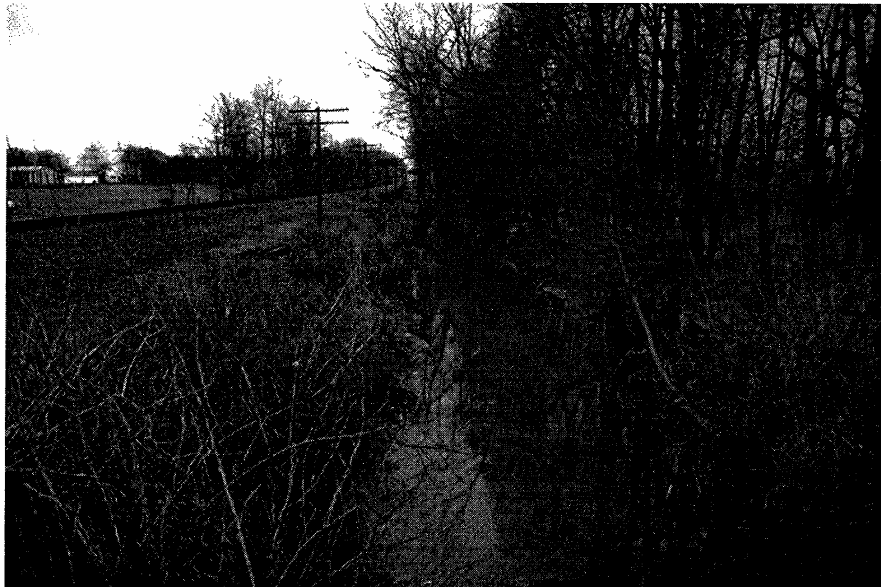
mature, large woody debris from branches and trees falling into the water will eventually provide habitat for fish and macroinvertebrates.

**Figure 4.3.3-1. Gundy Ditch at CR 27 East (upstream, 4/3/95).**

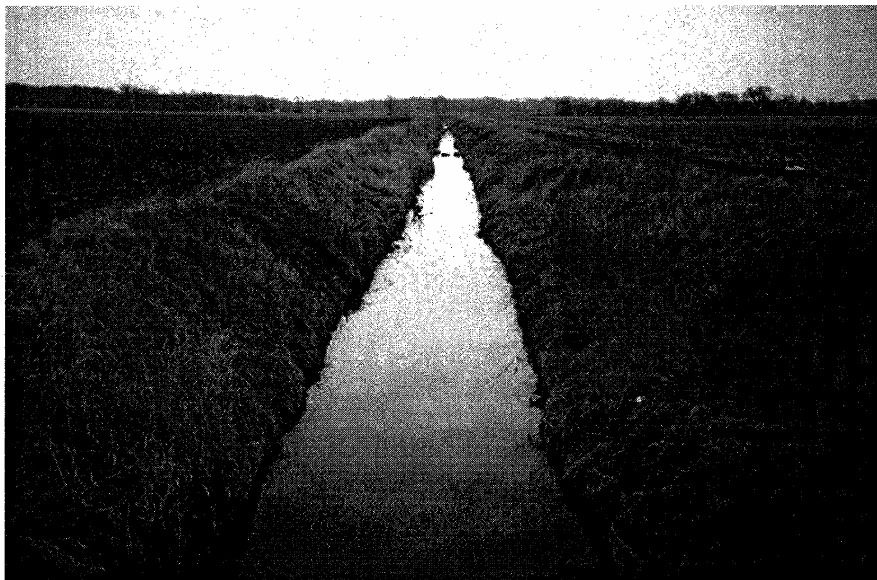
Swope Ditch (figure 4.3.4-1) is a hydraulic engineer's fantasy-come-true and an aquatic ecologist's nightmare. From the engineer's perspective, a straight ditch occupies the least land area and drains water quickly. The absence of woody vegetation allows easy access for channel maintenance. The grass (a non-native species) holds the ditch banks in place while allowing water to infiltrate through the bank. From the aquatic ecologist's perspective, the ditch is practically sterile. The lack of variation in habitat means few species will reside in this ditch. Compounding the problem for aquatic life, the quick water drainage means streamflow conditions vary from floodwaters during a storm to complete desiccation between rain events.

**Figure 4.3.4-1. Swope Ditch at CR 47 East (upstream, 4/3/95).**

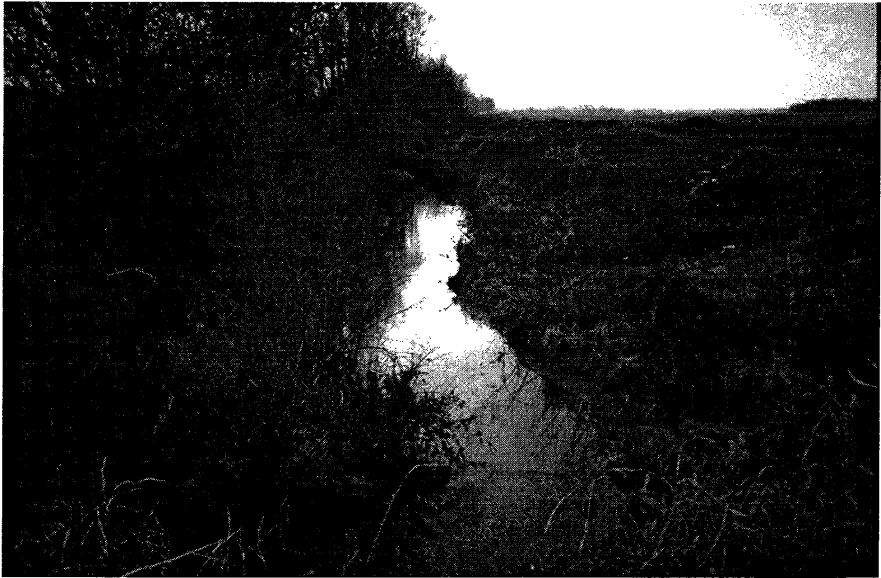
Cox Ditch (figure 4.3.5-1) was different from Swope Ditch in many respects. Although this waterway is a channelized ditch, the ditch was recovering from the effects of the previous channelization. One side of the ditch was lined with a thin band of young trees. Additionally, the stream channel was beginning to form meanders. Meanders create differential flow velocities in the stream, produce variable stream depths, slow overall water velocity, improve habitat quality, and eventually produce more stable water flow regimes.

**Figure 4.3.5-1. Cox Ditch at CR 5 North (upstream, 4/3/95). At the time of the photograph, vegetation was being removed from the right (east) bank and a dredge (a piece of heavy equipment used to "dredge-out" or channelize a stream) was observed in the distance adjacent to the stream.**

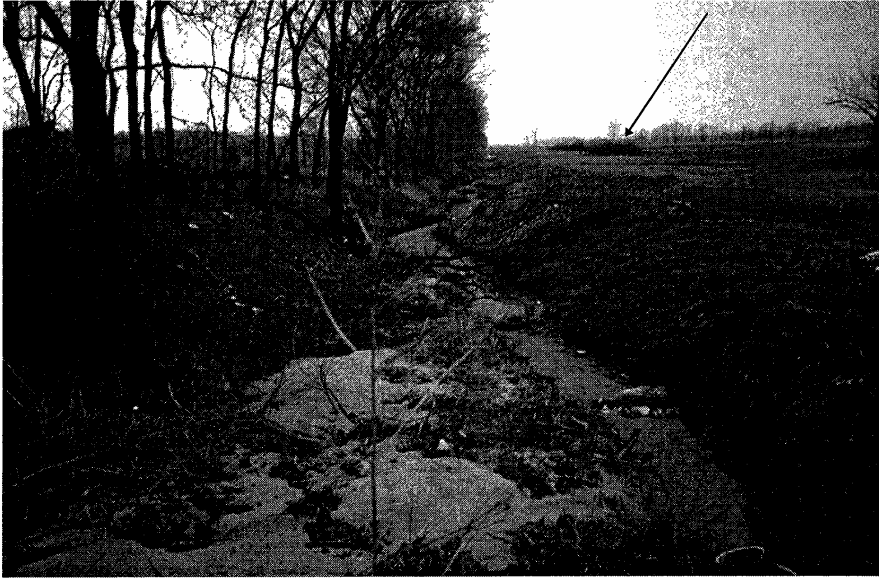
Figure 4.3.5-2 is further upstream on Cox Ditch. It should be pointed out that there is no water in Cox Ditch at this point. The streambed was dry downstream for as far as the author could see. Upstream from this point, there was standing water with some emergent aquatic plants growing in it.

**Figure 4.3.5-2. Cox Ditch at CR 49 North (downstream, 4/3/95). The dark horizontal objects lying in the farm fields adjacent to the channel are newly felled trees stacked into piles (arrow).**

In both figures 4.3.5-2 and 3, the extent of the vegetation removal on Cox Ditch can be seen. The channelization of this ditch, undoubtedly, resulted in greater environmental disruption than any environmental benefits the LARE project will produce. The denuded streambanks, exposed to erosion after reshaping, will contribute massive quantities of sediment to Otter Creek. Even after a grass layer returns to the banks, clumps of grass and soil will continuously slough off and into the channel to be carried downstream to Otter Creek.

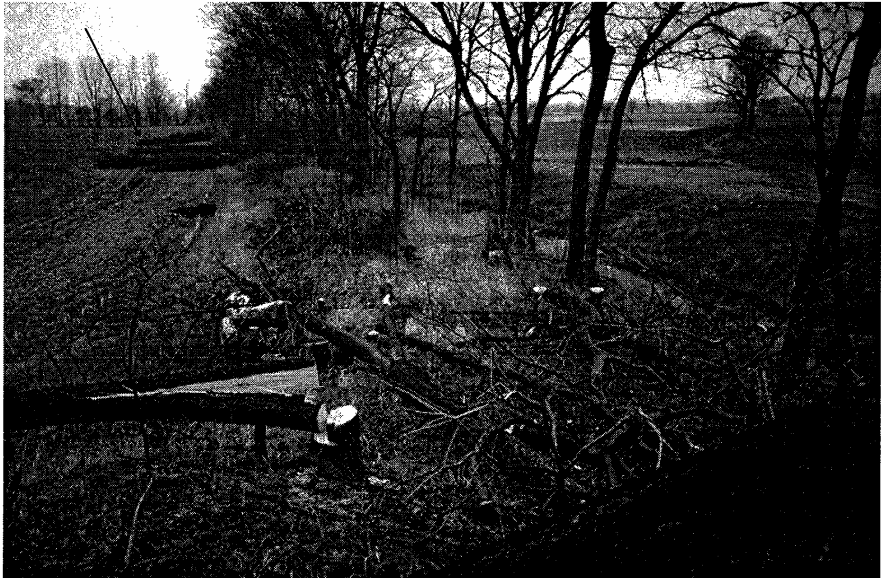
**Figure 4.3.5-3. Vegetation removal on Cox Ditch at CR 49 North (downstream, 4/3/95). The dark horizontal objects lying in the farm fields adjacent to the channel are newly felled trees stacked into piles (arrow).**
